**== USS TAYLOR (FFG-50) ==**  
**SEMAT II SHELL CONDITION ASSESSMENT**  
**SURVEY**  
**INTERIOR AREAS**  
**10/29/01 TO 11/09/01**

**PREPARED BY**  
**SUPERVISOR OF SHIPBUILDING CONVERSION**  
**AND**  
**REPAIR**  
**PORTSMOUTH, VIRGINIA**  
**11/10/01**

9 November 2001  
Serial# 1697AY – 118

Q.E.D. Systems, Inc. was tasked by the Supervisor of Shipbuilding Conversion and Repair, USN (SPORT) Portsmouth, VA to conduct an Ultrasonic Thickness (U/T) Survey of specific locations on board USS TAYLOR (FFG-50) during the period of 31 October 2001 – 8 November 2001.

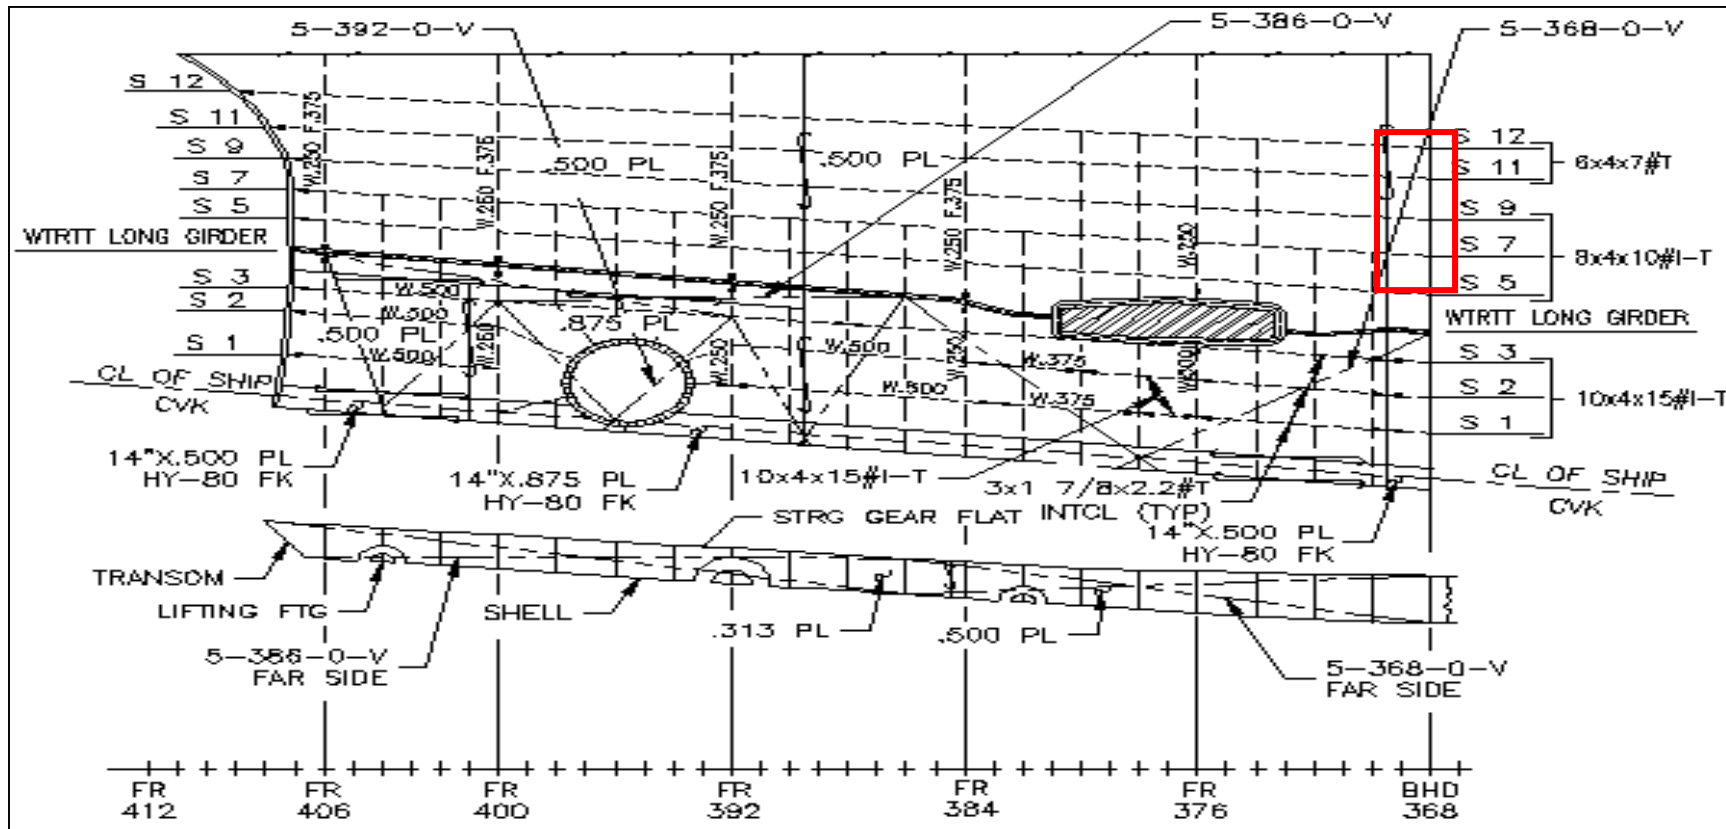
| LOCATION | AREA | RESULTS |
|---|--|---|
| 5-368-01-E STEERING GEAR ROOM | BILGE AREA, STARBOARD EDUCTOR | APPROX 20 SF OF CORROSION AND SCALING ON SHELL PLATE AND STRINGERS THINNING |

RUST AND SCALING AT TRANSVERSE WELD SEAM APPROX 2 FT AFT OF BHD (368)

STARBOARD SIDE, EXPANDED  
VERTICALLY, RED BOX INDICATES AREA

| RECOMMEND SHIP'S FORCE CLEAN AREA TO BARE METAL, PRESERVE AND PAINT APPROXIMATELY 20 SF | | | | | | | | |

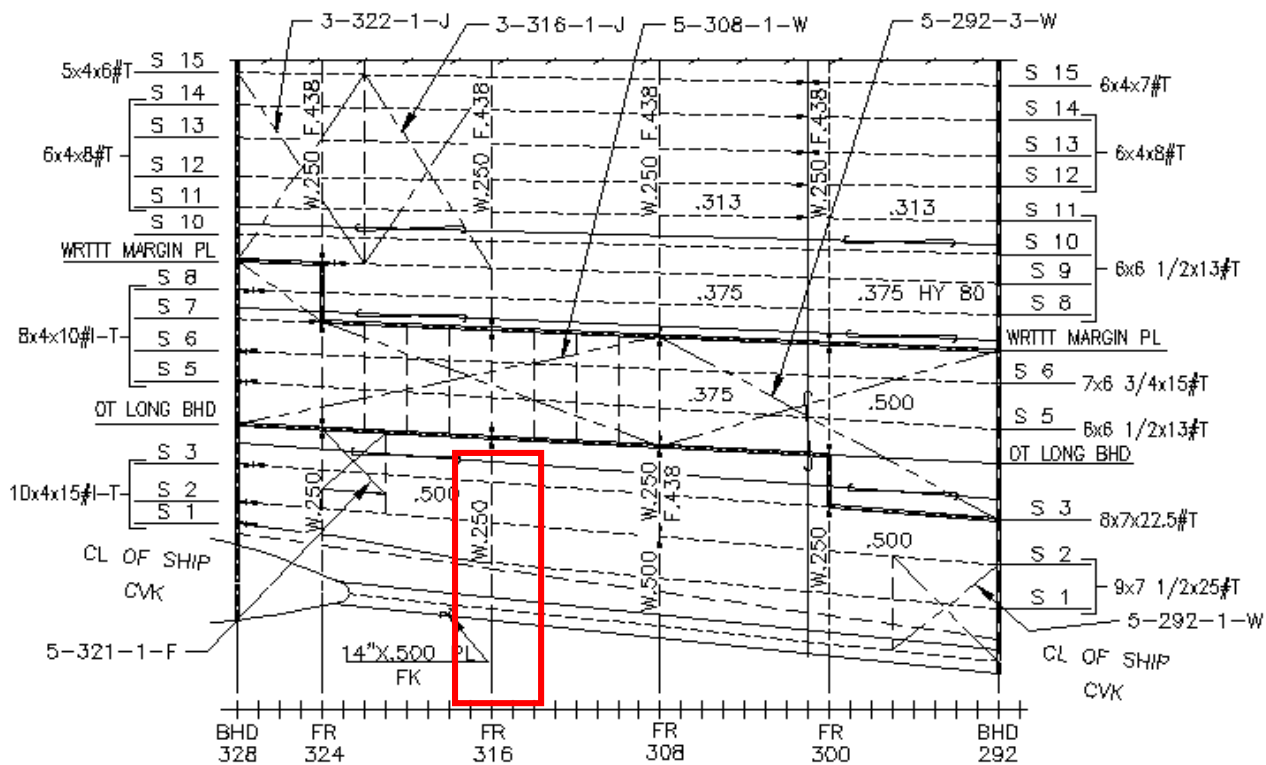
**USS TAYLOR FFG-50)**  
**AUXILIARY MACHINERY ROOM 3 (5-292-0-E)**

| LOCATION | AREA | RESULTS |
|---|--|---|
| 5-292-0-E AMR 3 | CENTER LINE, TRANSVERSE WEB FRAME 316 | TRANSVERSE WEB FRAME IS HOLED ABOVE THE SHAFT. APPROX 16 LF OF ANGLE STIFFNERS IS DETERIORATED ON FWD SIDE OF TRANSVERSE WEB FRAME. |

TRANSVERSE WEB FRAME (316) LOOKING AFT, CORRODED STIFFENER.

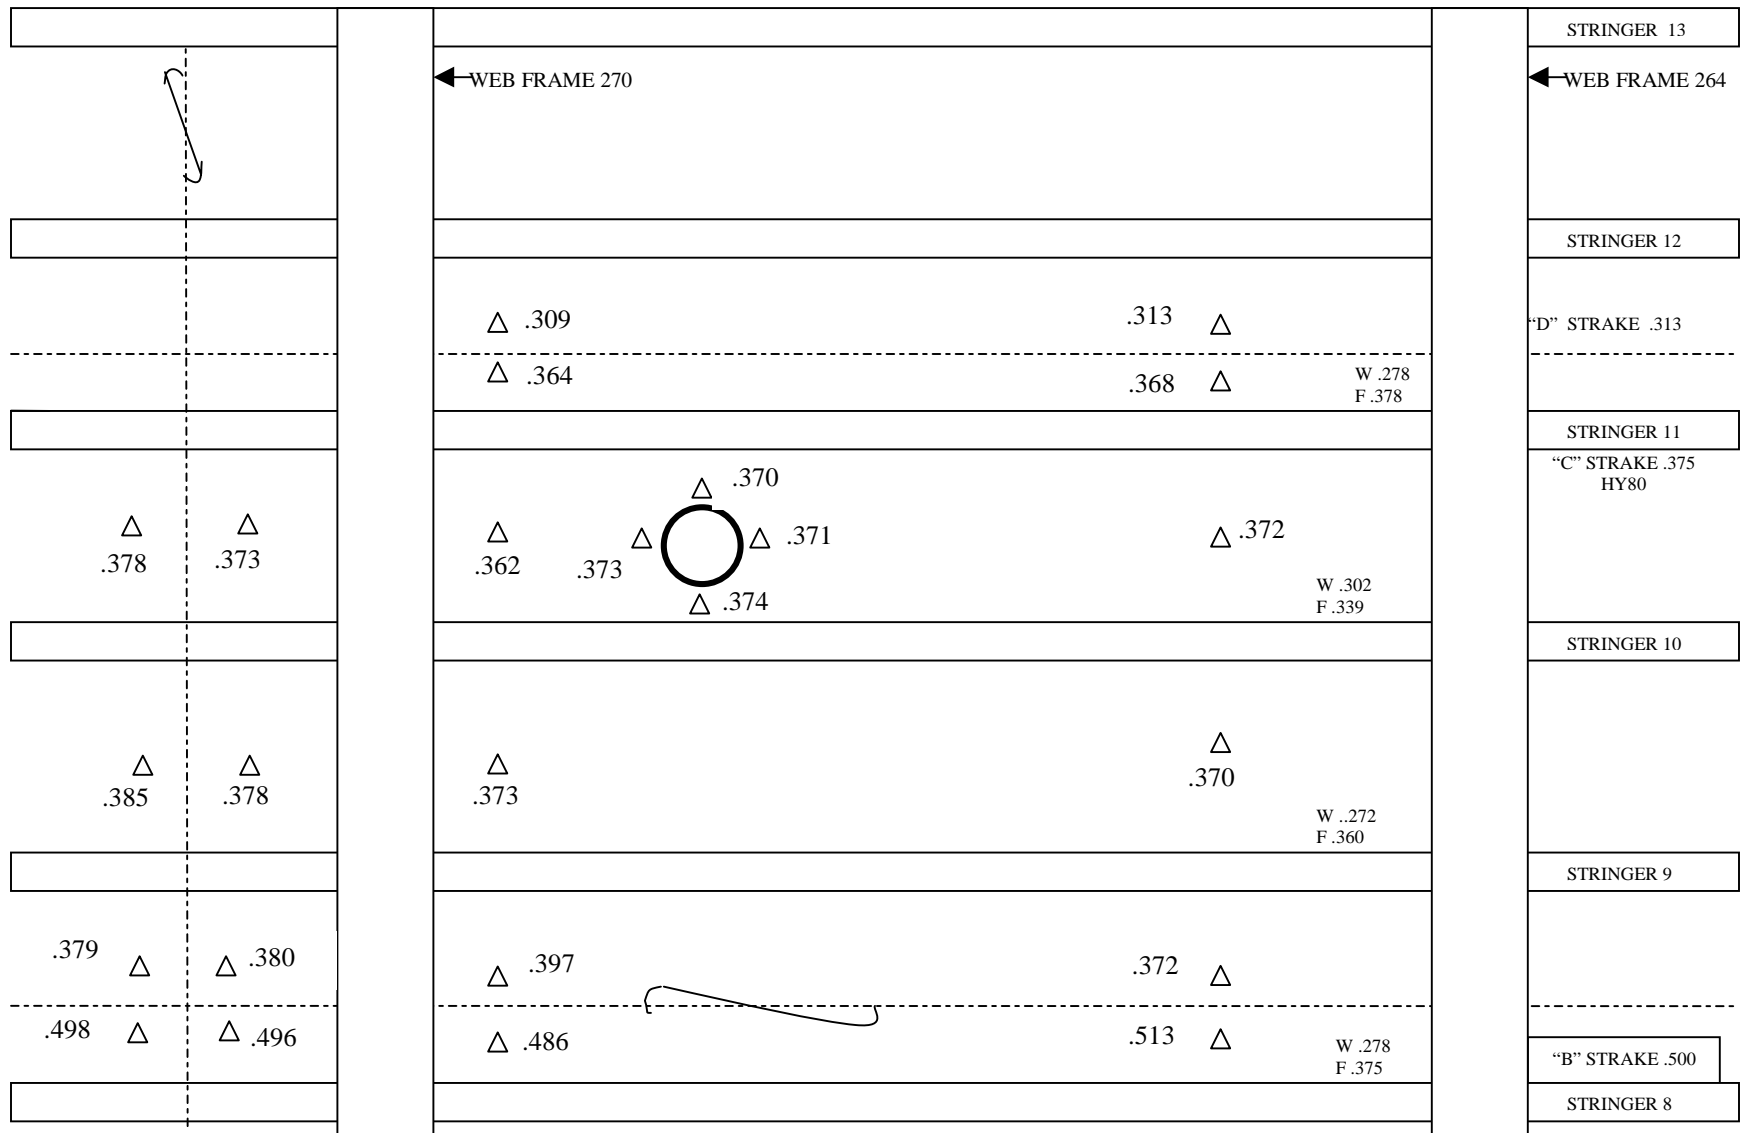
**USS TAYLOR (FFG-50)**  
**MAIN ENGINE ROOM (5-250-0-E)**  
**PORT SIDE**

| LOCATION | AREA | RESULTS |
|---|--|---|
| 5-250-0-E MER | PORT SIDE, FR (264-270), AT TRANSVERSE WELD SEAM FROM MARGIN PLATE TO STRINGER (13) | APPROX 80 SF OF SURFACE RUST AND HEAVY PAINT SEPARATION. |

RED BOX INDICATES WHERE U/T  
READINGS WERE TAKEN  
SEE FOLLOWING PAGE FOR DRAWING

W. STRINGER WEB  
 F. STRINGER FLANGE  
 Δ SHELL PLATE  
 B STRAKE .500 MIN .375  
 C STRAKE .375 MIN .282  
 D STRAKE .313 MIN .236

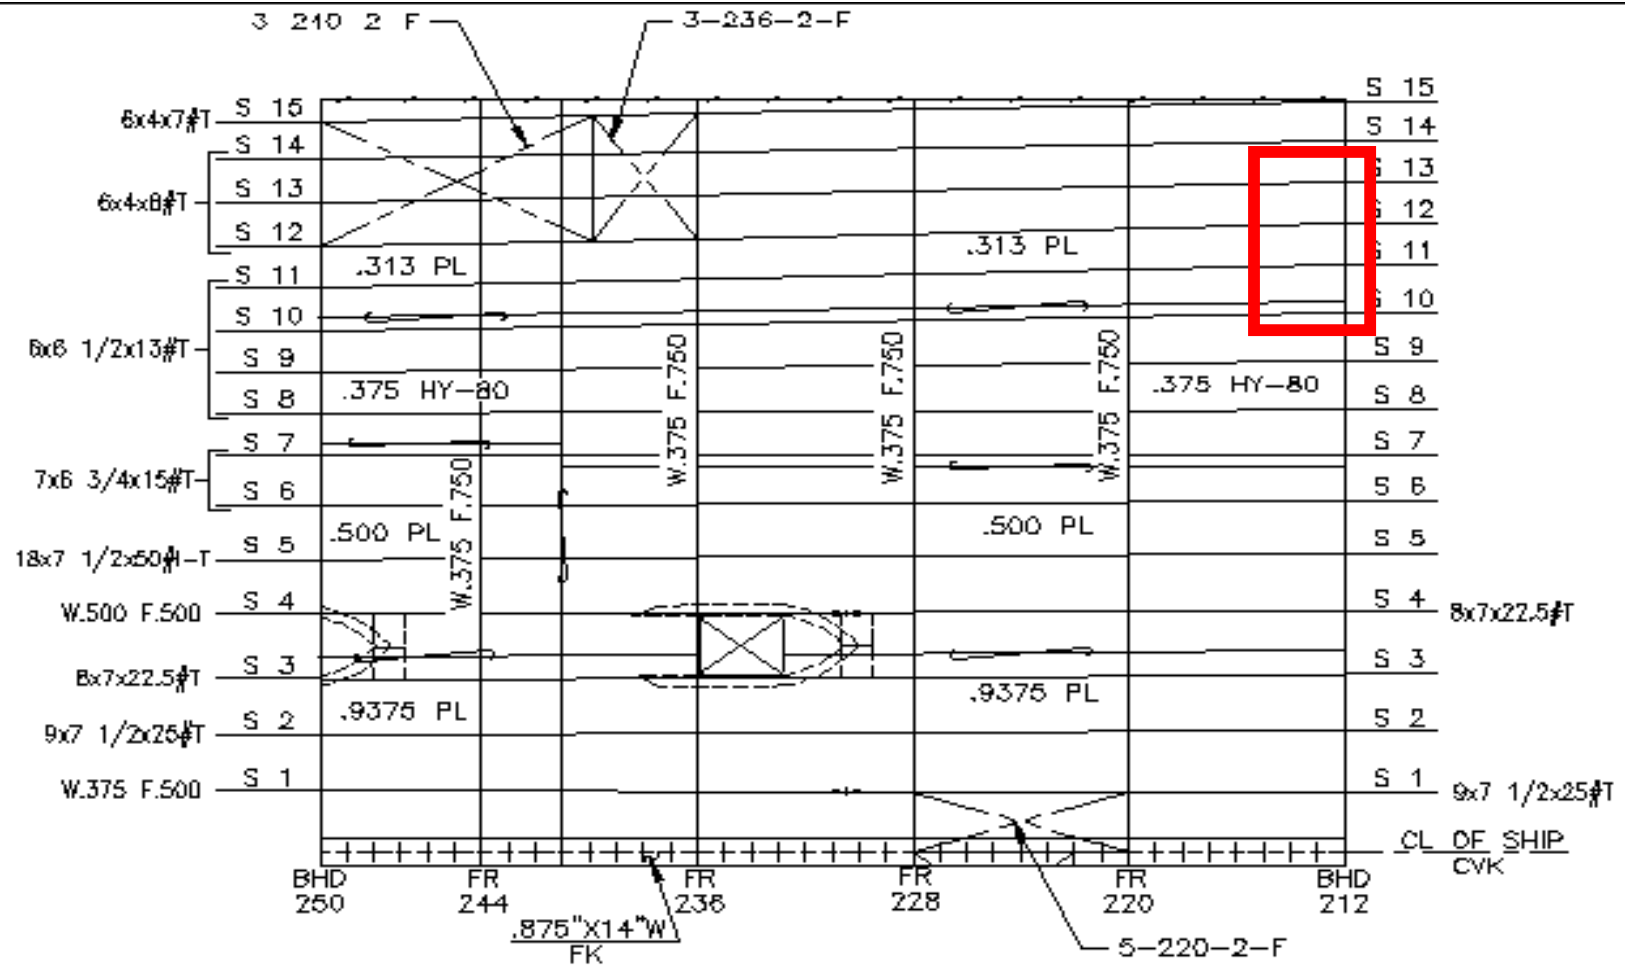
USS TAYLOR (FFG-50)  
AUXILIARY MACHINERY ROOM 2 (5-212-0-E)

| LOCATION | AREA | RESULTS |
|---|--|---|
| 5-212-0-E AMR 2 | PORT, BULKHEAD(212) FROM ESCAPE TRUNK TO U/L GRATING | APPROX 20 SF OF CORROSION AND PAINT SEPARATION. RECOMMEND NOT REPLACING LAGGING. |

STRINGER (7), LOOKING INBOARD NEAR BOTTOM OF ESCAPE TRUNK

RED BOX INDICATES AREA WHERE U/T  
READINGS WERE TAKEN.  
REFER TO FOLLOWING PAGE FOR DRAWING.

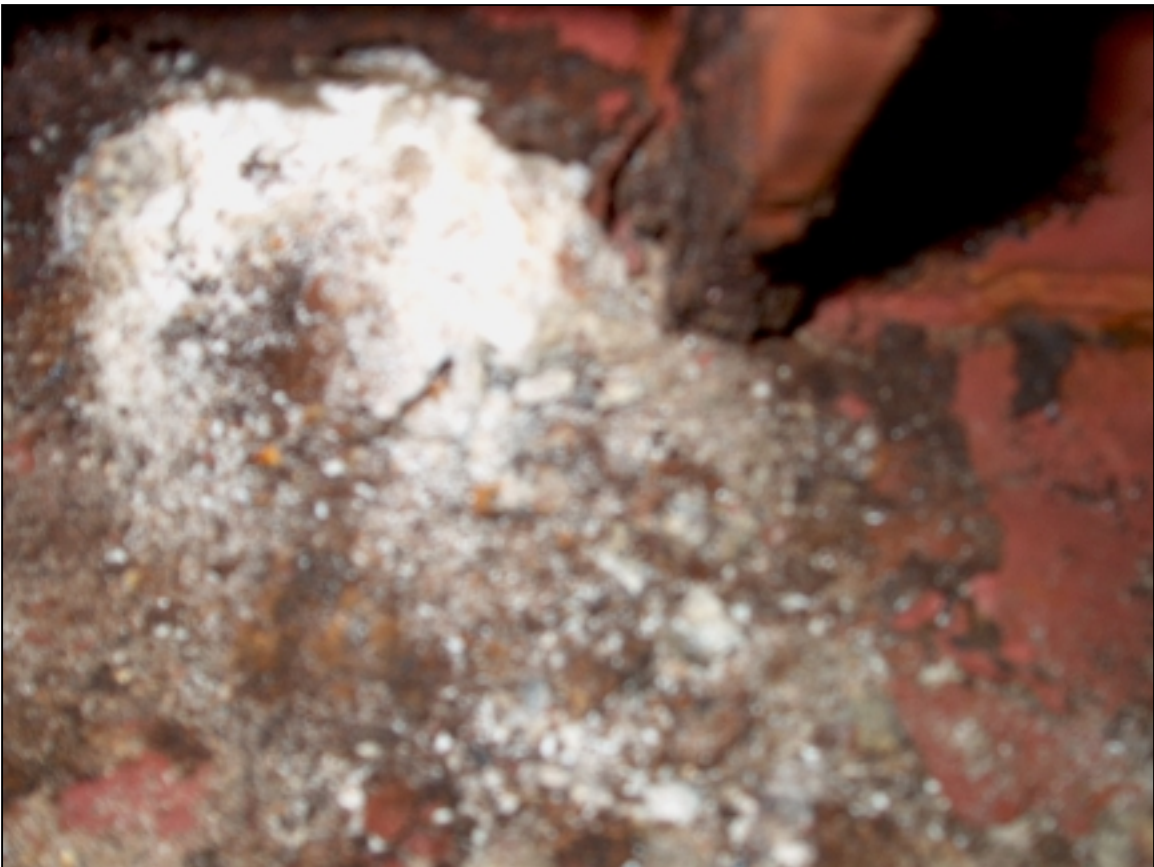
**USS TAYLOR (FFG-50)**  
**AUXILIARY MACHINERY ROOM 1 (5-180-0-E)**

| LOCATION | AREA | RESULTS |
|---|--|---|
| 5-180-0-E AMR 1 | PORT SIDE, UNDER REEFER COMPRESSOR NO. 2, UNDER HALON BOTTLE STATION AND INBOARD OF BALLAST BLOCKS, AFT OF WF (196). | APPROX 200 SF OF CORROSION AND PAINT SCALING. |

CORROSION INBOARD OF BALLAST BLOCKS AFT OF WF (196).

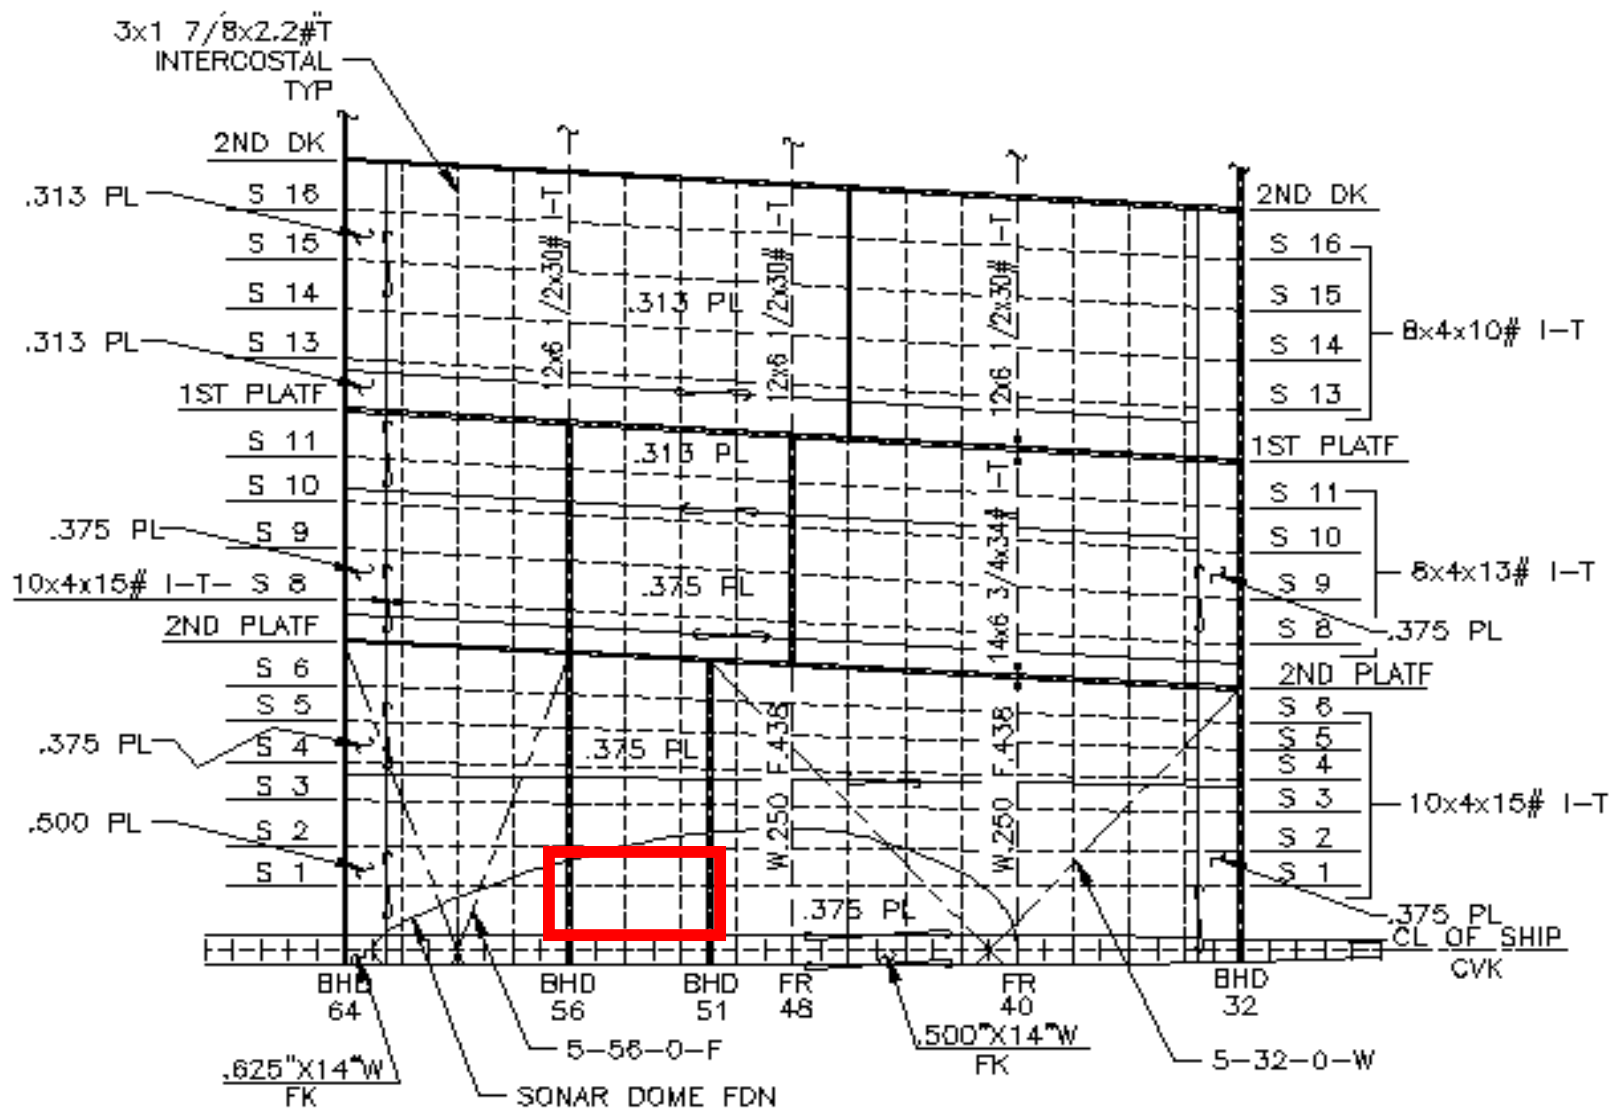
USS TAYLOR (FFG-50)  
EDUCTOR ROOM (5-51-0-Q)

| LOCATION | AREA | RESULTS |
|---|--|---|
| 5-51-0-Q FWD EDUCTOR ROOM | PORT AND STBD SIDE BILGE AREA. | APPROX 8 LF OF VERTICAL STIFFNER, APPROX 1 LF OF FLANGE IS DETERIORATED AND ENTIRE BILGE AREA IS FILLED WITH WATER AND CORROSION. |

CORRODED (2 X 3) VERTICAL STIFFNER.

RED BOX INDICATES AREA WHERE U/T  
READINGS WERE TAKEN  
SEE FOLLOWING PAGE FOR DRAWING

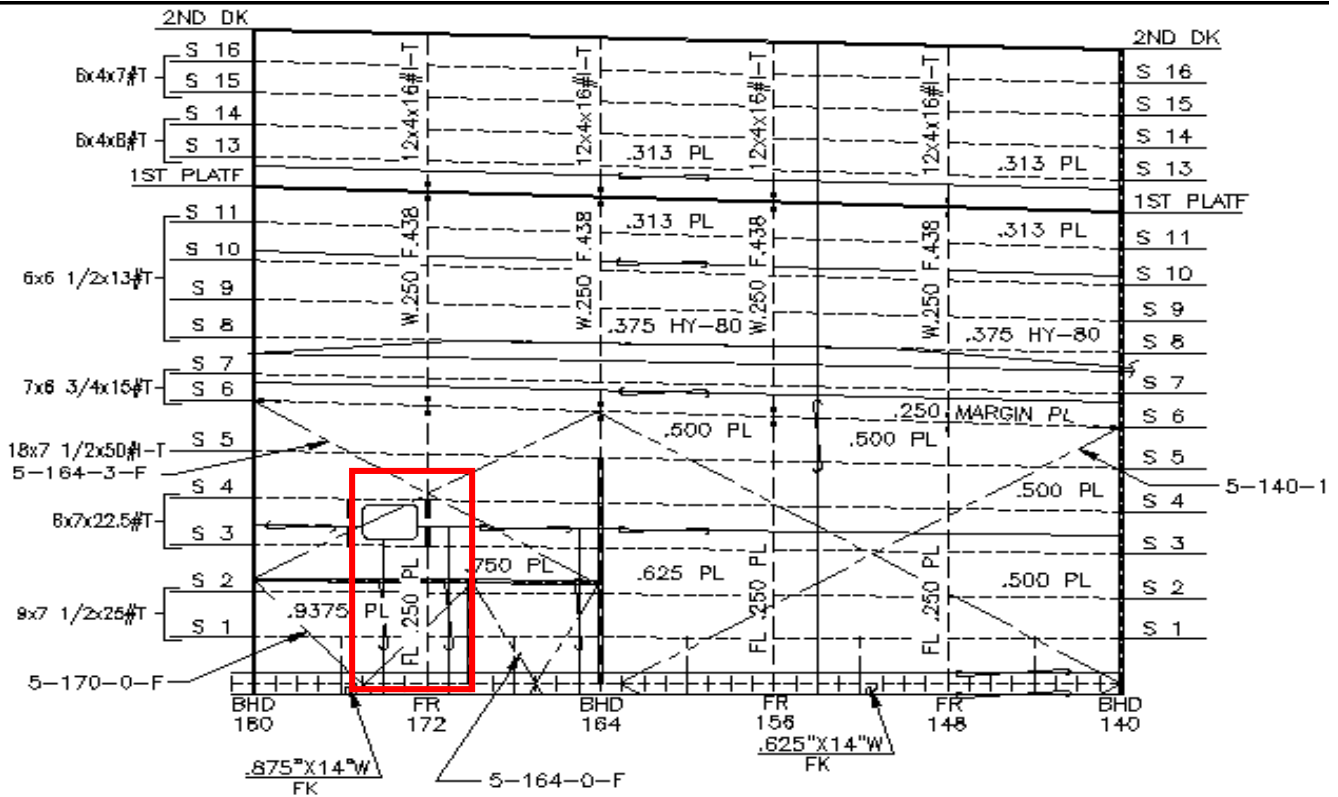
**USS TAYLOR (FFG-50)**  
**FIRE PUMP ROOM (4-172-1-E)**

| LOCATION | AREA | RESULTS |
|---|--|---|
| 4-172-1-E FIRE PUMP ROOM | BILGE POCKET AREA, BHD (172-180) | APPROX 35 SF OF SURFACE RUST AND PAINT SEPARATION. |

BILGE POCKET AT BHD (180)

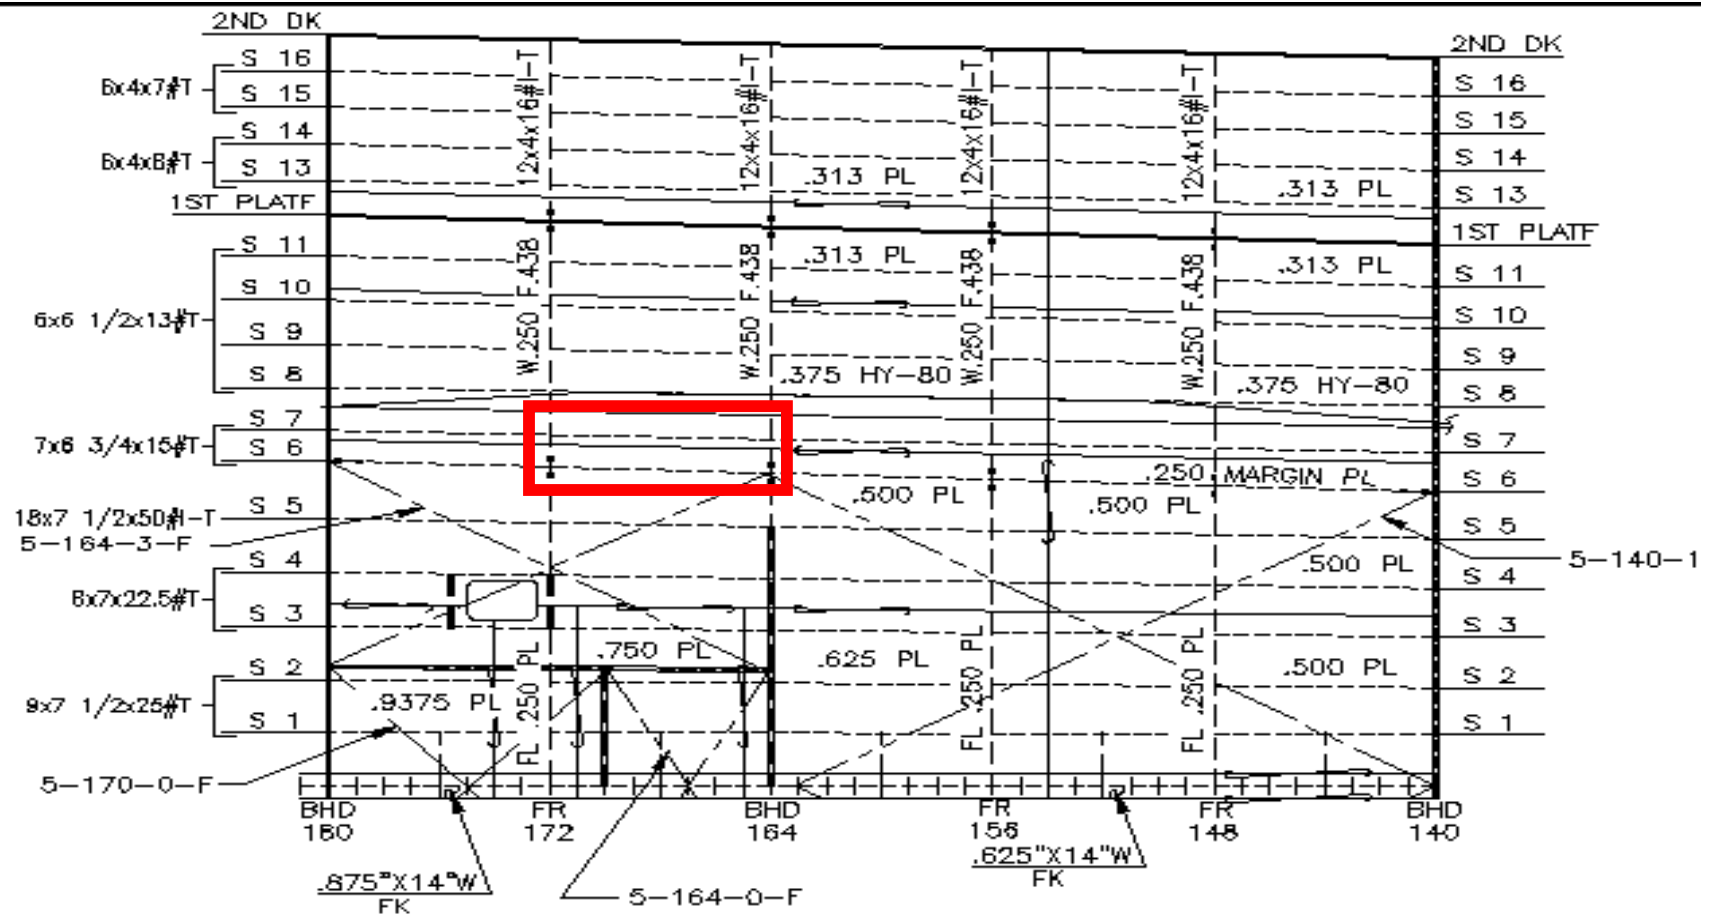
**USS TAYLOR (FFG-50)**  
**CHT ROOM (4-160-0-Q)**

| LOCATION | AREA | RESULTS |
|---|--|---|
| 4-160-0-Q CHT ROOM | PORT SIDE, BILGE POCKET AREA FROM BHD (164-180) | APPROX 45 SF OF SURFACE RUST AND PAINT SEPARATION. |

PORT SIDE BILGE POCKET AT BHD (164) POOR BONDING AND MOISTURE CAUSE  
PAINT SEPARATION, U/T READINGS WERE SATISFACTORY.

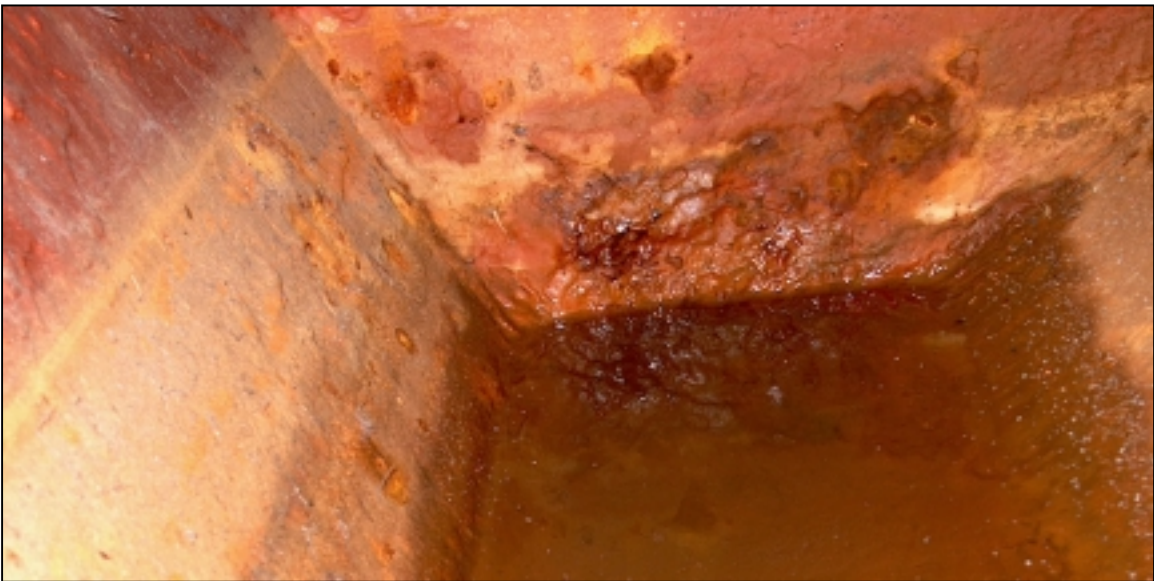
**USS TAYLOR (FFG-50)**  
**LAUNDRY ROOM (4-140-0-Q)**

| LOCATION | AREA | RESULTS |
|---|--|---|
| 4-140-0-Q LAUNDRY | PORT SIDE, WEB FRAME (160) WHERE IT MEETS THE SHELL AND MARGIN PLATE, ENTIRE BILGE POCKET AREA | APPROX 1 SF OF WEB FRAME (164) IS HOLED. APPROX 80 SF OF BILGE AREA HAS RUST AND PAINT SEPARATION. |

WEB FRAME (160) WHERE IT MEETS SHELL AND MARGIN PLATE IS HOLED. WATER IS TRAPPED IN THE BILGE POCKET. WEB FRAME (160) SEPARATES THE LAUNDRY AND THE CHT ROOM.

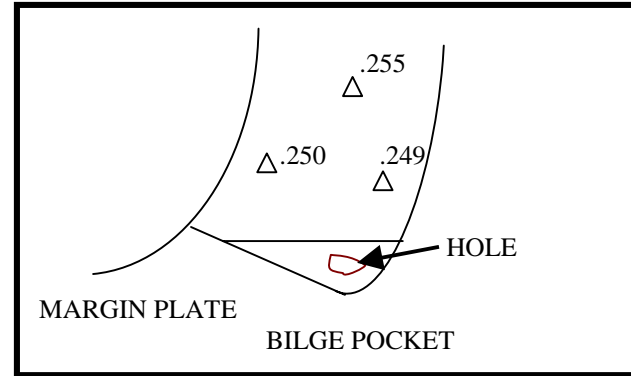
HOLE IN WEB FRAME

| Δ .501 | Δ .499 | Δ .500 | Δ .498 | Δ .496 | .502Δ |
| DESIGN THICKNESS .500<br>MINIMUM .375 | | | | | |

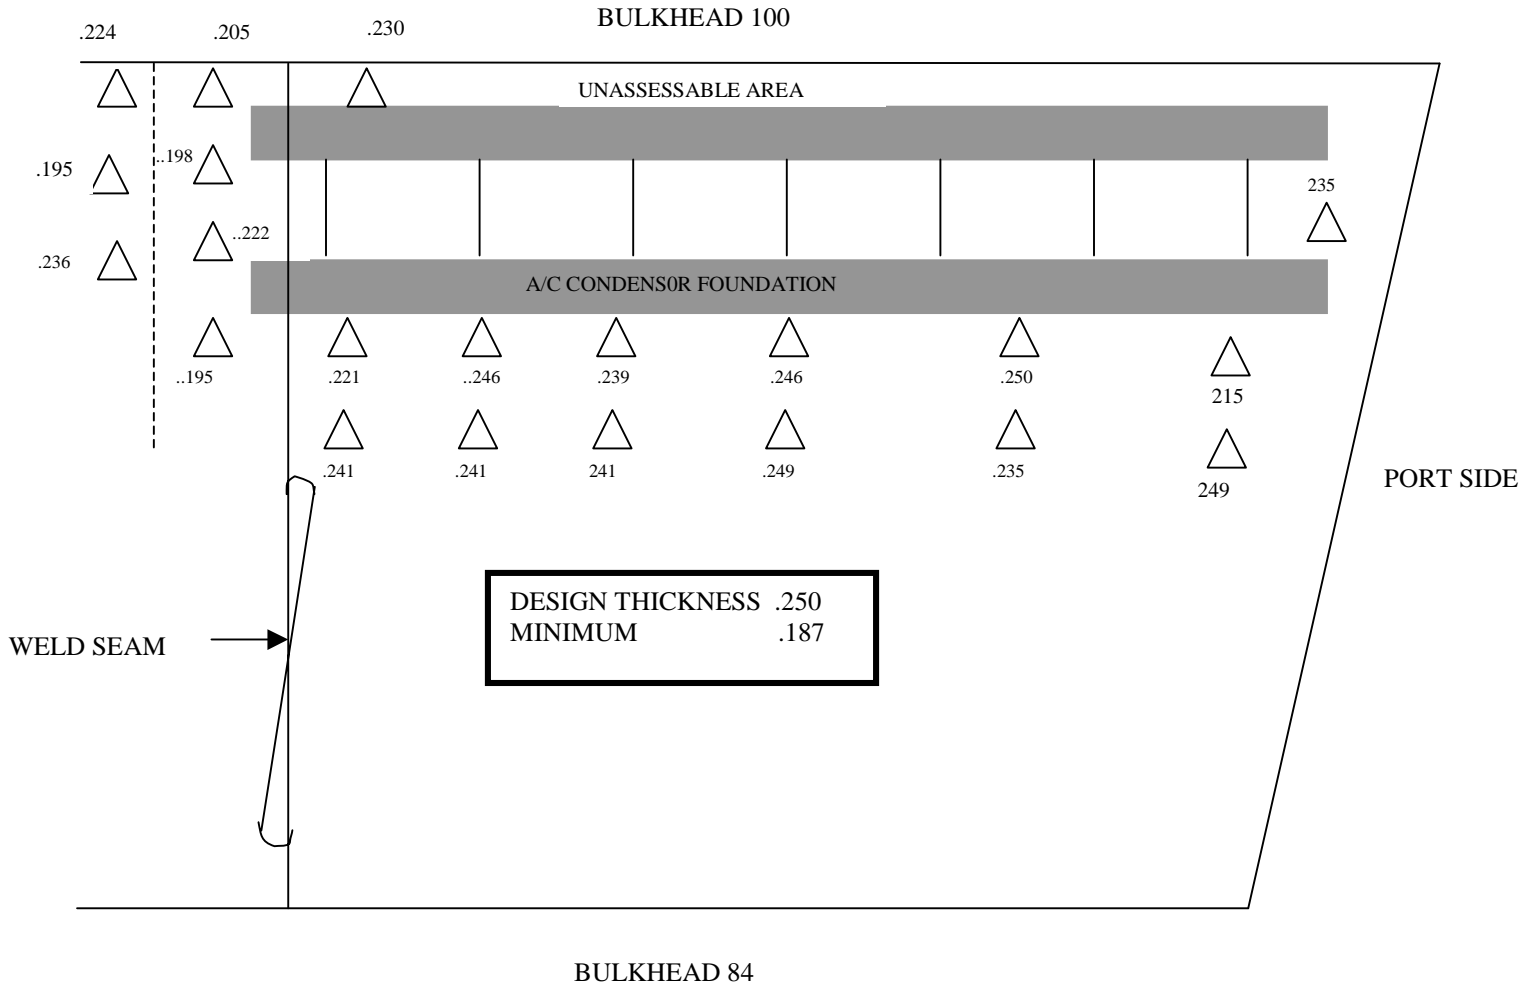
**USS TAYLOR (FFG-50)**  
**A/C MACHINERY ROOM (3-84-0-E)**  
**PORT SIDE**

| LOCATION | AREA | RESULTS |
|---|--|---|
| 3-84-0-E A/C MACHINERY ROOM | PORT SIDE, TANK TOP / DECK | APPROX 40 SF OF CORROSION AND LIGHT THINNING. |

TANK TOP / DECK AND BHD (100) BETWEEN A/C PLANT AND PORT SHELL. BECAUSE  
THE A/C PLANT IS SO CLOSE TO BHD (100) AND THE PORT SIDE SHELL PROPER  
MAINTENANCE IS IMPOSSIBLE.
